2000 52' Jefferson Hershine Rivanna Cockpit Motor Yacht
"SAMPLE ONE"

Report of Marine Survey

"SAMPLE ONE"

May 1, 2023

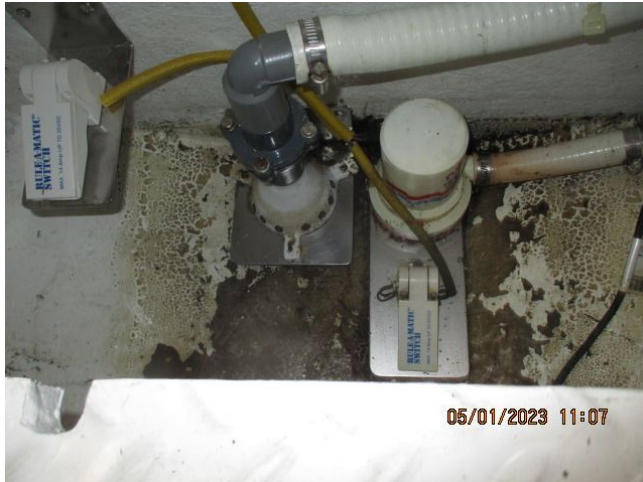
FINDING B-1

GENERAL BILGE CONDITION

Slight water was observed collecting in the bilges.
Gelcoat surface material was beginning to lift and possibly clog bilge pumps.
