2014 45' Outremer Marine 45' Performance Catamaran
"SAMPLE TWO"

Report of Marine Survey

"SAMPLE TWO"

2014 45' Outremer Marine 45' Performance Catamaran

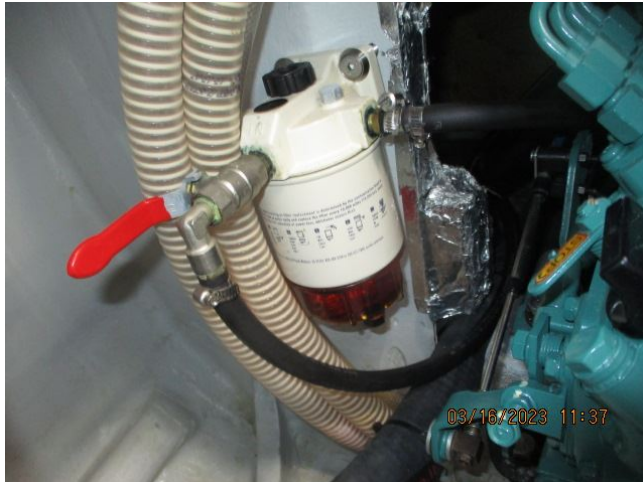
FINDING B-6

No significant sediment or algae was observed in the Primary fuel filter's sight bowls or on their diffusers. Monitor/service often.

Recommend installing the Approved Heat Shields that meet ASTM FS1201 Certification on the Primary fuel filter sight bowls, as necessary.

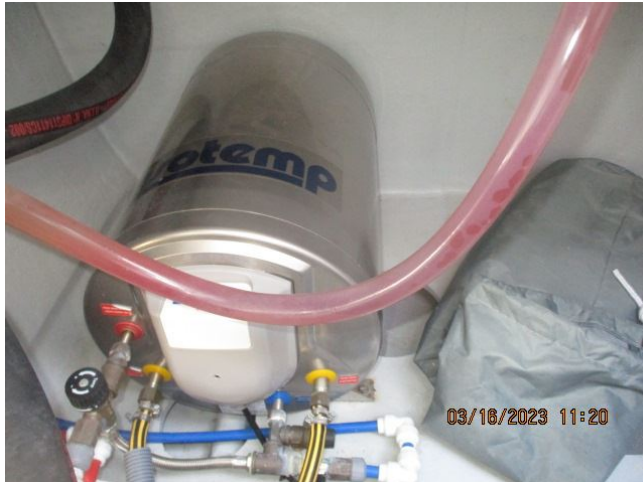
FINDING B-7

A leak was observed at the water heaters external fittings.

Investigate further, and service, repair or replace as necessary.
