2014 45' Outremer Marine 45' Performance Catamaran
"SAMPLE TWO"

Report of Marine Survey

"SAMPLE TWO"

2014 45' Outremer Marine 45' Performance Catamaran

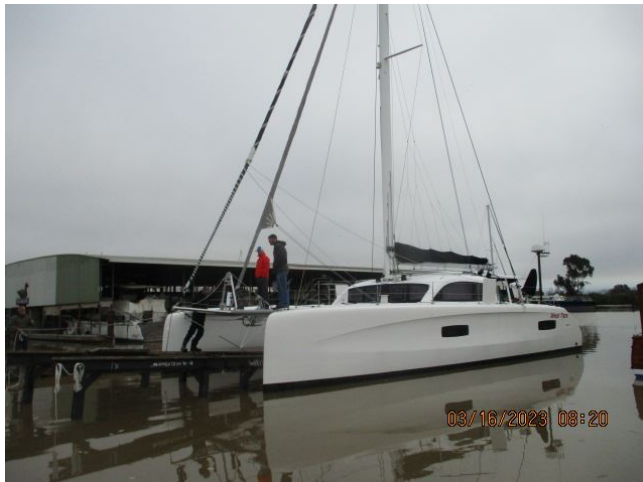
HULL DESIGN TYPE

Performance catamaran hulls with fine entry plumb bows; high rise bridge deck with ample clearance from waterline; port and starboard dagger boards.

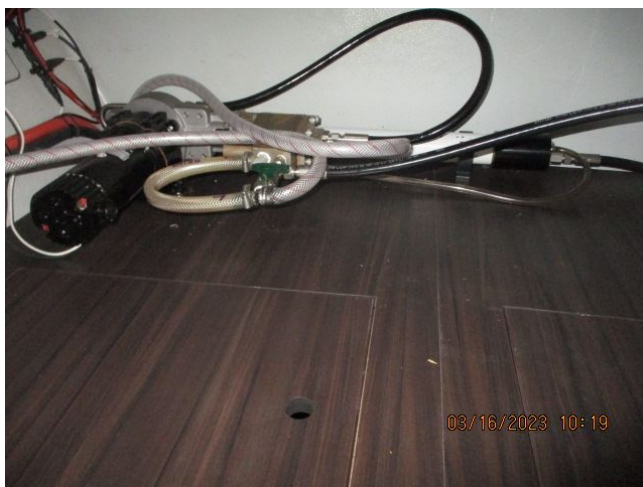
DESALINATION (FRESHWATER MAKING) SYSTEM

Aqua-Matic by Sea Recovery.(Not tested.)

Not determined (data tag was inaccessible).

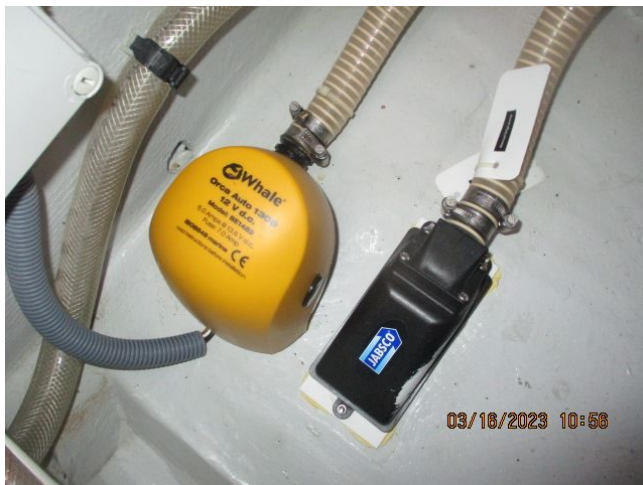
MANUAL BILGE PUMPING SYSTEMS

Two (2) Jabsco manual hand bilge pumps. One in each hull. (Required test/prove).

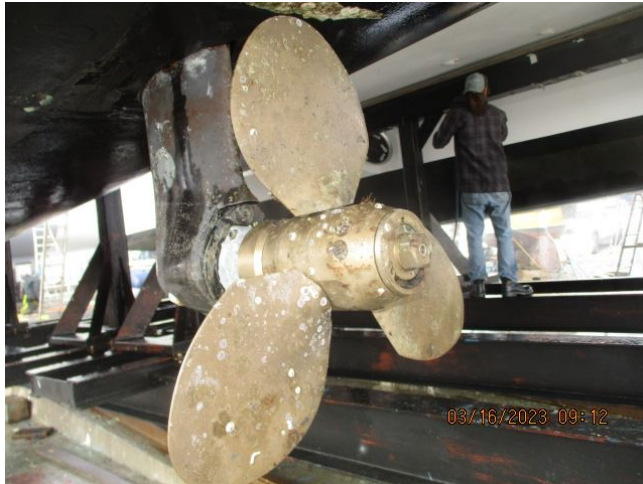
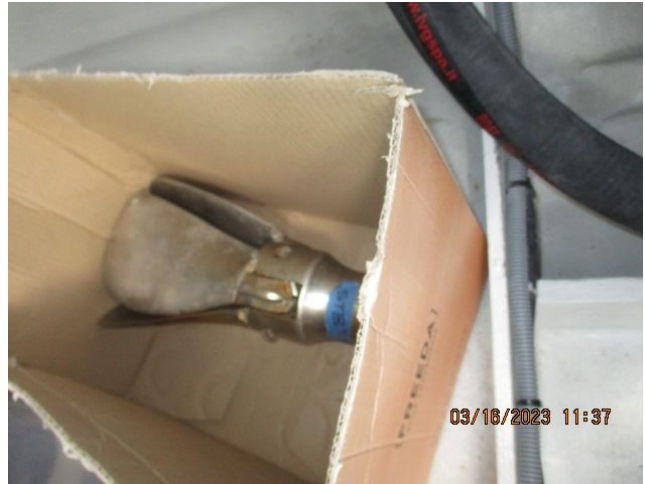
Two (2) spare bronze alloy Auto Prop three bladed feathering propellers. (Note: one spare propeller's blades show corrosive deterioration.)

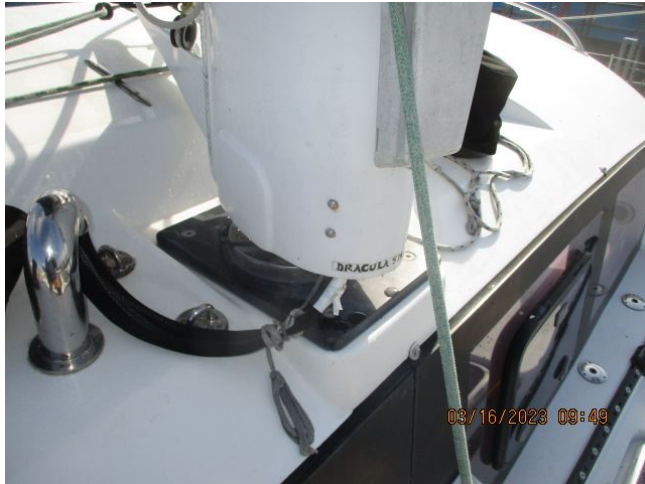
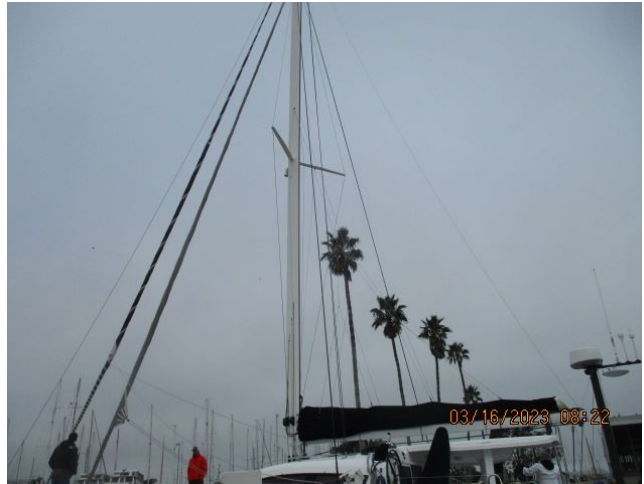
Single spreader rig (Carbon Fiber swept back type, with Fractional Rig).

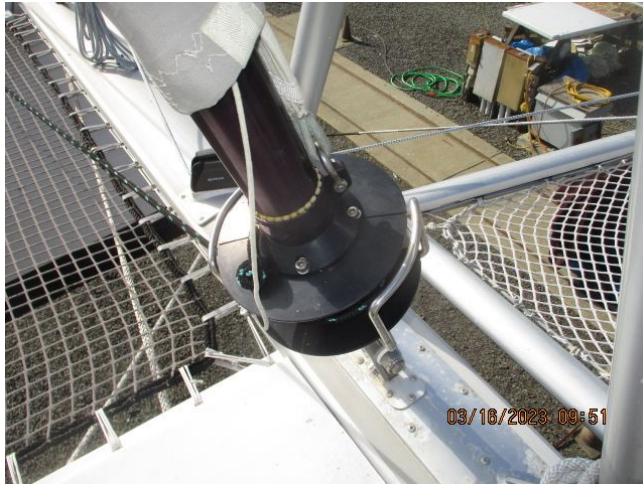
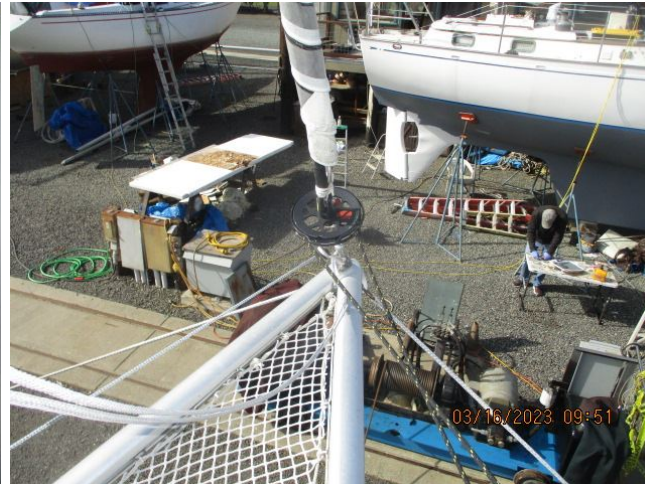
Halyards were braided and color coded with no wire splices.

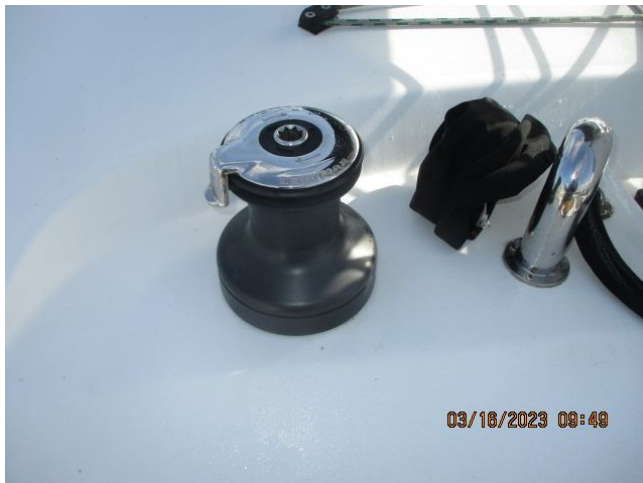
Lewmar Winches: Five (5) #50st-2. One (1) #50st-2 12 volt. Powered up. Demonstrated.

Recommend servicing and/or lubricating all of the sailing component's moving parts (cam cleats, clutches, blocks, tracks, furling gear, winches, etc.) as necessary.
